Non Destructive Testing of Drystone Walls

Warren, Laura

Awarding institution:
University of Bath

May 2018

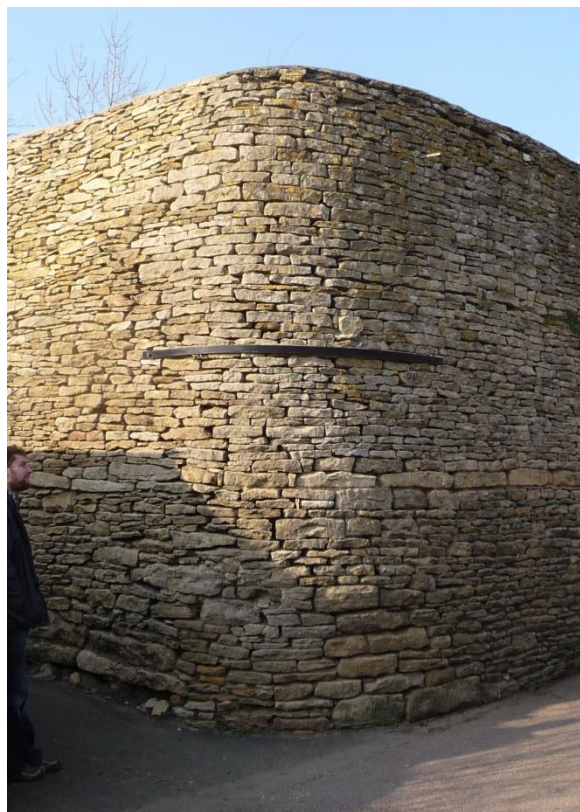
Figure 3.2a: Wall tie to corner of wall shown in Figure 3.2.

Figure 3.2: Garden retaining wall, Sherston. Retaining wall to garden above, approximately retaining for two thirds of height. This wall is unusually straight at its face with little batter, with two distinct bands of regular stone (A and B). There is also a tie plate to the corner of the wall (C) shown more clearly in Figure 3.2a

The walls in Figures 2.2 and 2.3 both retain gardens immediately adjacent to the road in Sherston, Wiltshire. These walls are in excess of 4m in height with a parapet, and retain gardens behind. They show a number of modifications and alterations, along with historical repairs, such as the tie band that can be seen on the corner of the wall in Figure 3.2. They also show signs of extensive pointing and mortaring, particularly to their bases as seen in Figure 3.3; this is a common modification to drystone walls, which could be carried out for a number of reasons. Due to the proximity of the road, it is likely here it is to prevent damage from salt spray from the road. However, mortaring of the wall in this way can prevent the free flow of water through the wall and create a build-up of water pressures, which can be detrimental to the wall's stability. However, at the time of visit these walls showed very little signs of distress or movement.

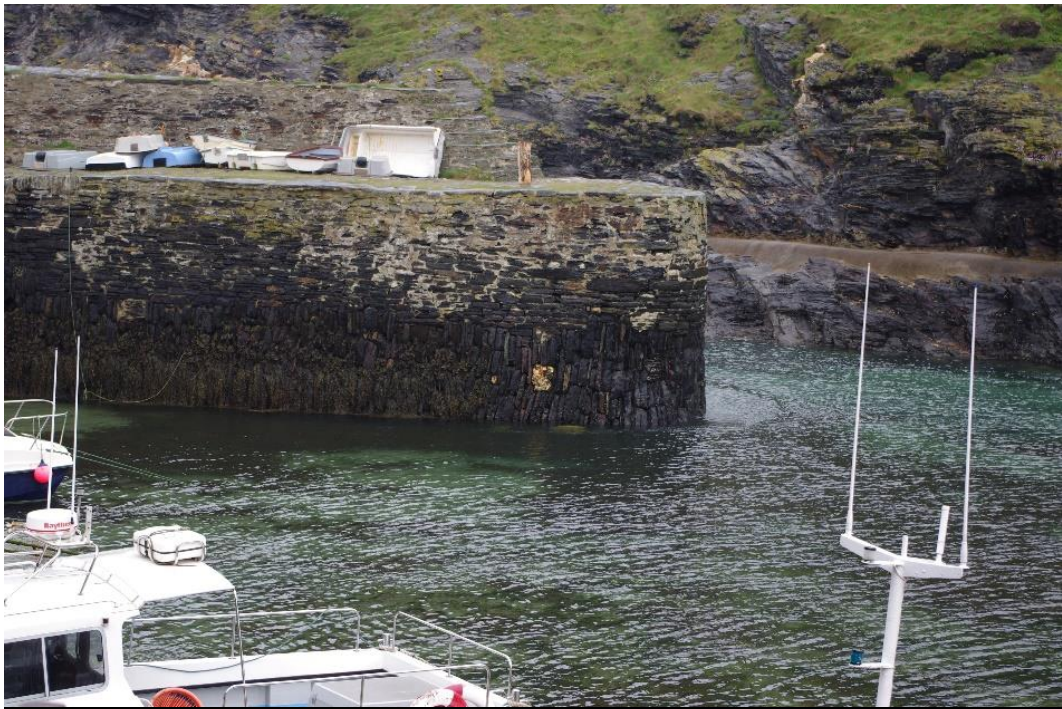
Figure 3.8: Harbour wall, Boscastle, Cornwall. This image shows the variation in construction above and below the water line. Below the high tide mark construction is vertical and above the high water line the construction is horizontal. Much of the horizontal construction has also been mortared.

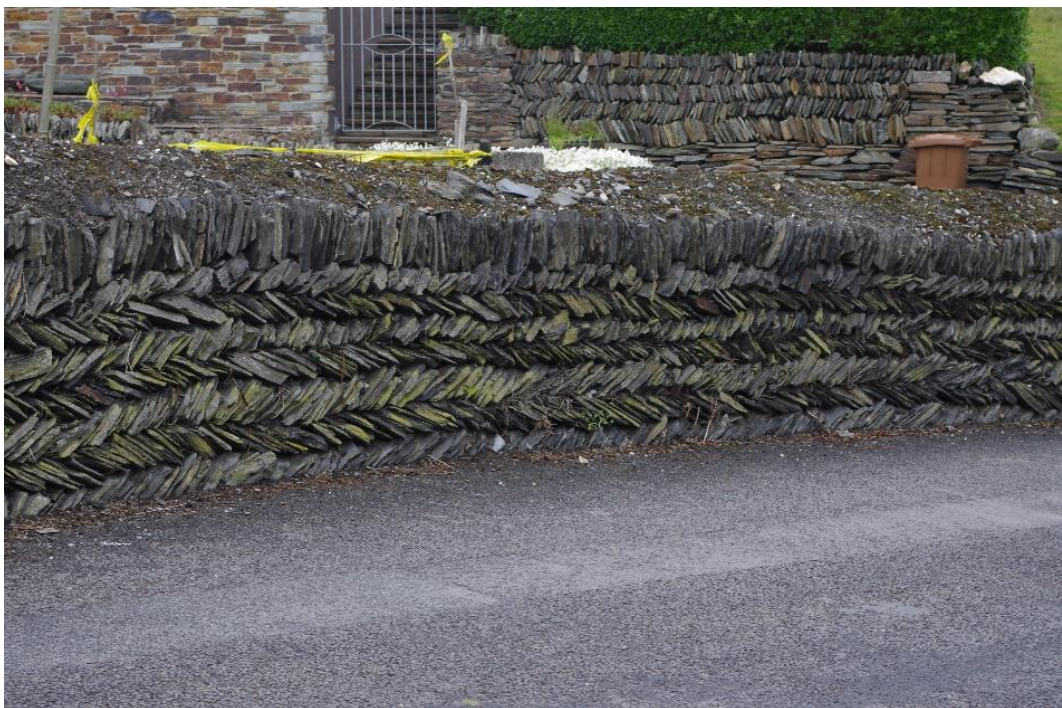
Figure 3.9: Herringbone wall in Boscastle, Cornwall. Herringbone construction is widely associated with the West Country and Cornwall in particular. Mainly used in Cornish banks such as in this image, where only small amounts of soil are retained. Often perceived as more decorative than other constructions.

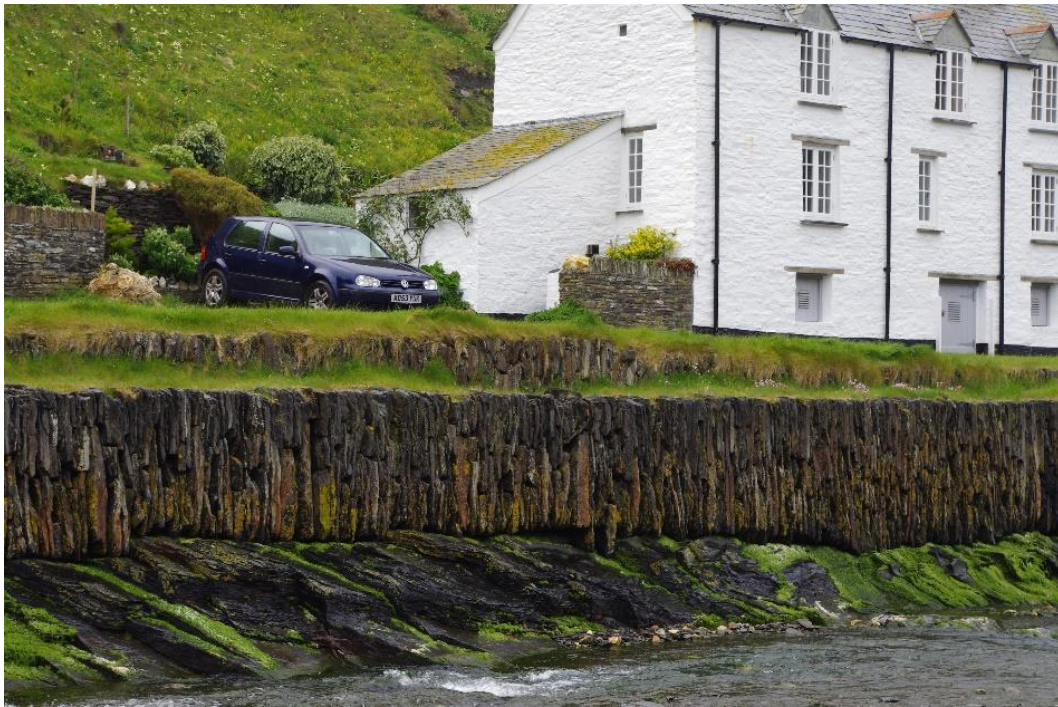
The vertical style was mainly found along the north coast and was associated with constructions formed of slates. This area is known for its slate, with the well-known Delabole slate quarry nearby, from which the slate is recognised for its extreme durability and can therefore remain serviceable for over 100 years. This durability makes slate from this area a good walling material, particularly in the harsh tidal environment. The slate used in these walls was very smooth sided and comparatively thin, with rough edges that were not worked other than at the face (Figure 3.10). This style of construction was also found in non-coastal structures, along with some horizontal and herringbone construction, the latter being generally for non-critical structures. The vertical construction was very well packed with no spacing between the stones. It was also possible to see the top of some walls and this tight overlapped construction could be seen throughout the width of the wall (Figure 3.11).

Figure 3.10: Vertical slate construction, Boscastle, Cornwall. This is an estuary wall in the tidal region, typical of the walls lining the river throughout Boscastle.

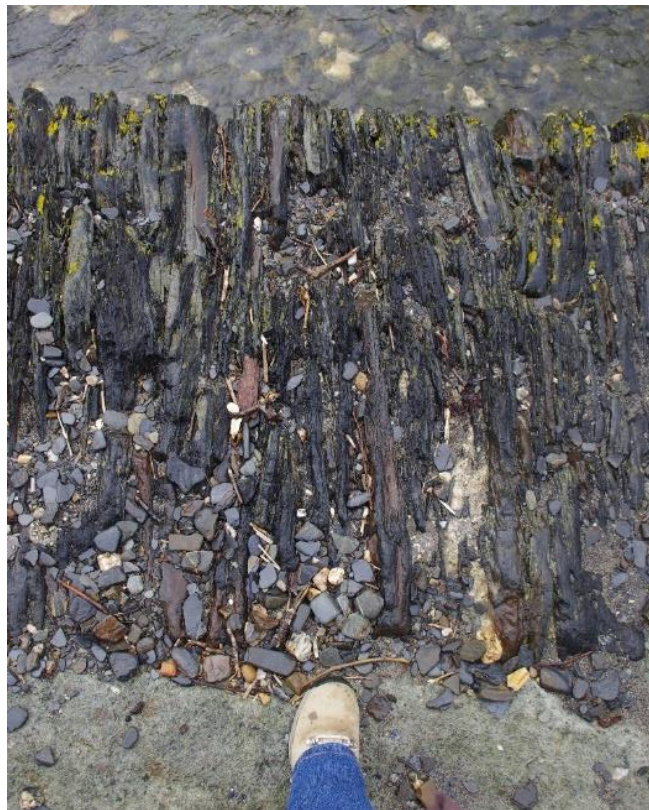
Figure 3.11: Construction through wall, Boscastle, Cornwall. Image shows potential depth of these walls and how stones are placed throughout the wall width to form a continuous construction, mimicking the overlapping normally seen at the wall face. Also shows the size of some of the individual stones.

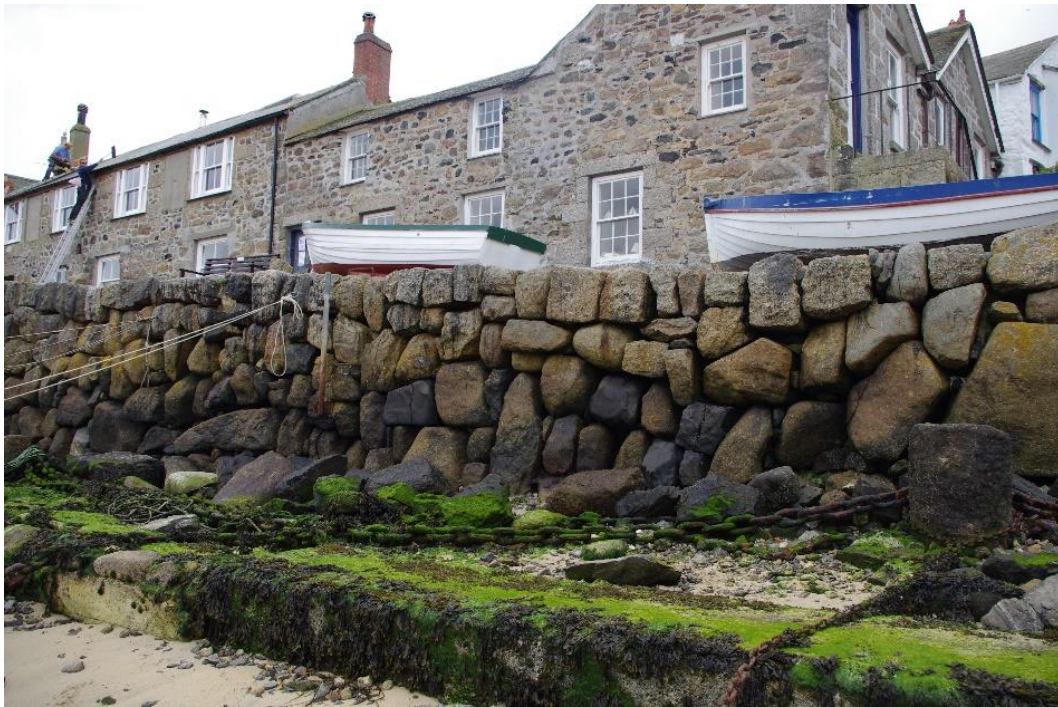
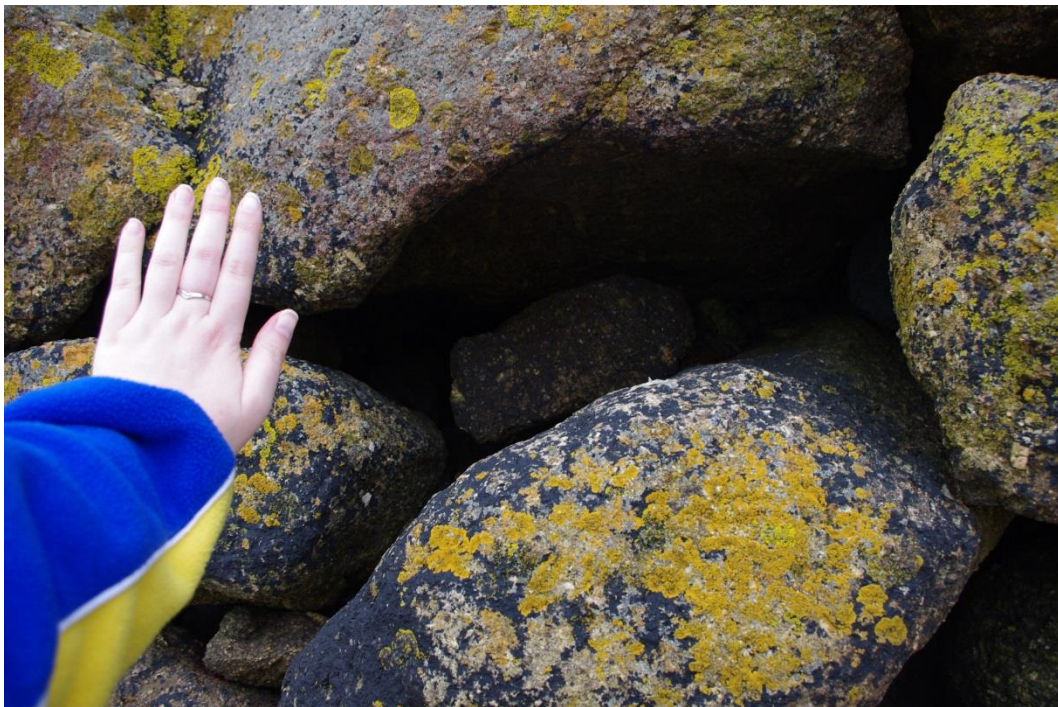
Random construction was predominantly found in the southwest, where the principal stone type is granite. Walls were often formed of rounded boulders giving an open construction (Figure 3.12).

Figure 3.12: Open random construction, Mousehole, Cornwall. Constructed using large granitic boulders, this wall has a comparatively open structure with large gaps between the stones (b); it is assumed these aid dissipation of wave energy.

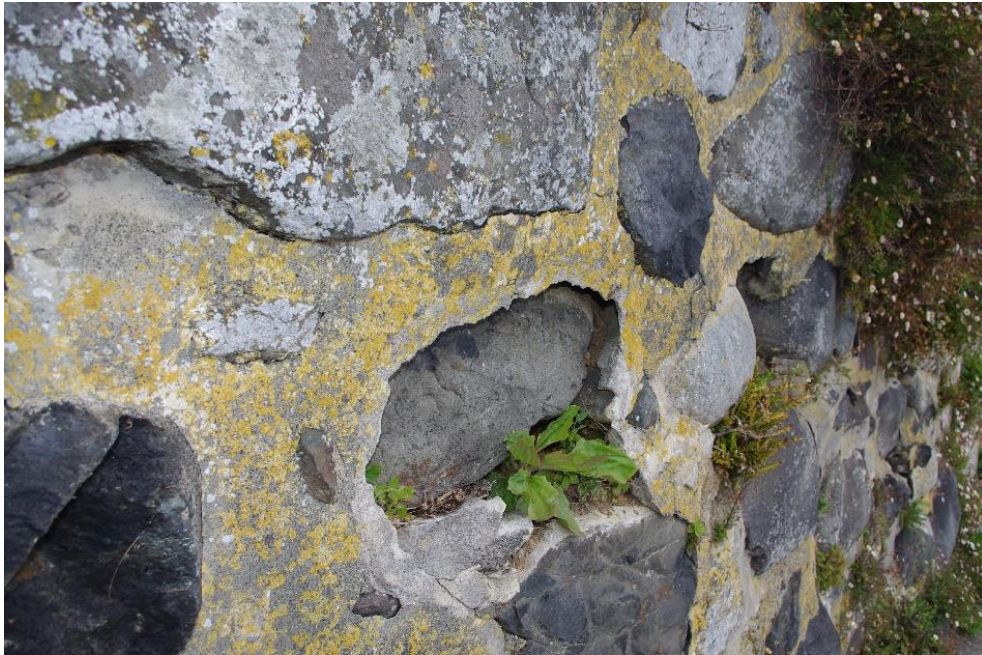
(a) Face of wall

Figure 3.13: Mortared wall face, Mousehole, Cornwall. This wall has been pointed at its face. In places this has been broken away, and stones have moved (a). The drystone construction can be seen behind the face (b).

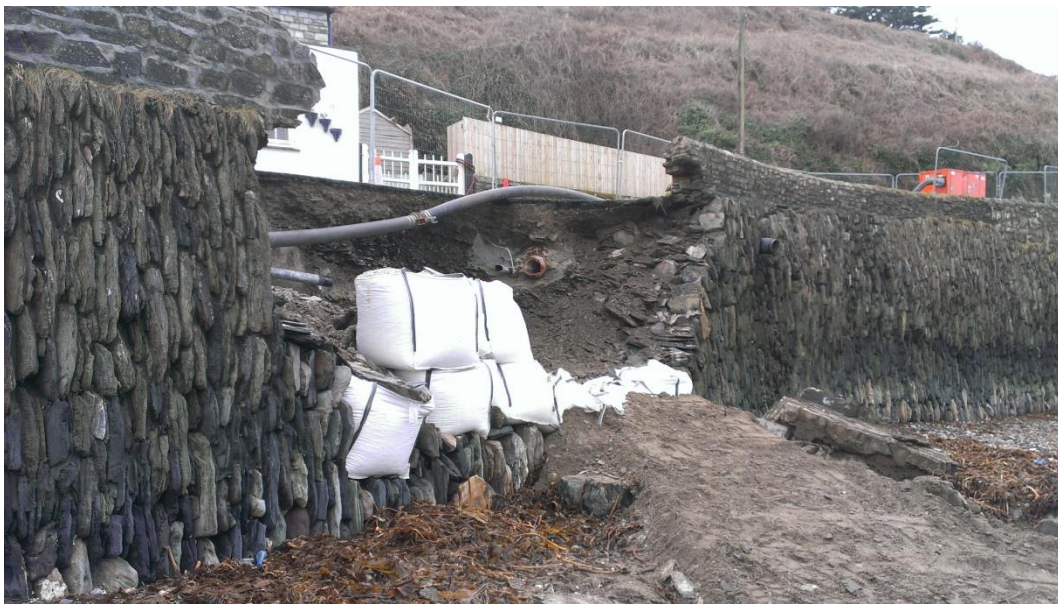
(b) Wall collapse following storms – taken March 2014

Figure 3.14: Mortared wall, Port Gavern, Cornwall. Much of this wall section is mortared. In February 2014 large storms hit the Cornish coast and this section of wall collapsed (b). The area of collapse seems to coincide with the visually different area to the centre of the original image. This wall forms a retaining wall to the back of a small bay directly facing the sea, forming the main protection to the road and houses beyond. It is mostly above the high water line.

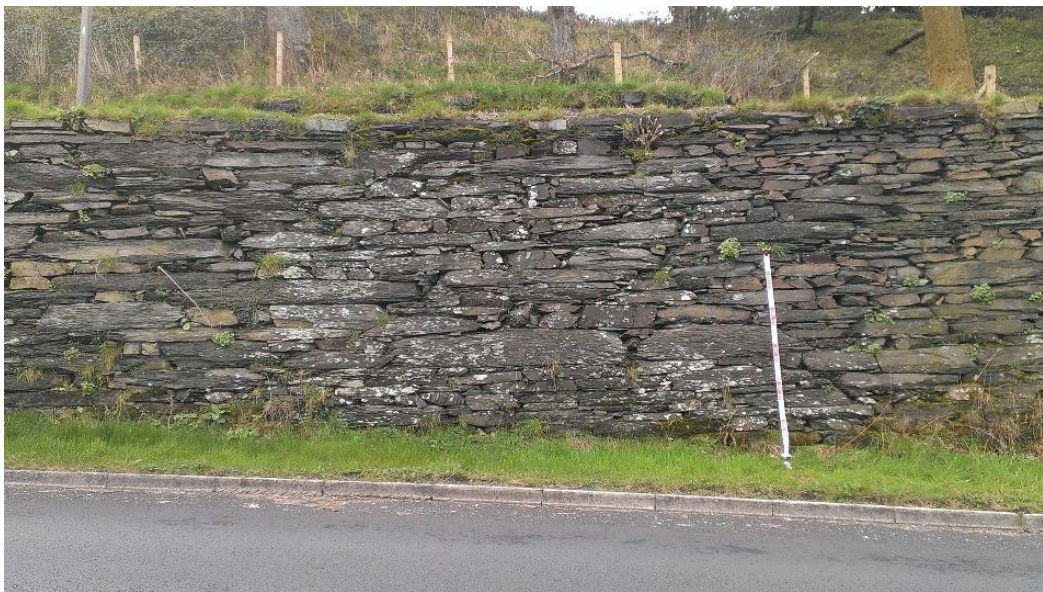
Figure 3.18: Supporting Wall on A497, Ffestiniog Railway. The railway runs directly behind the wall, which was reconstructed following a major collapse in the 1980's.

The wall in Figure 3.18 supports the railway on the A497 on the outskirts of Minffordd. The stones used to construct this wall like much of the railway are significant size. This wall is built on sand, and had problems due to subsidence prior to the late 1980's and early 1990's, when a drainage scheme was implemented. There was also a major collapse in the 1980's due to high water both sides of the wall, due to rainfall and high tides, along with vibrations from passing lorries. However, this collapse was not as bad as it may have been due to slumping of the outer wall, which restrained the old inner wall allowing it to simply drop vertically. Since the implementation of correct drainage, there have been significantly less problems with the wall.

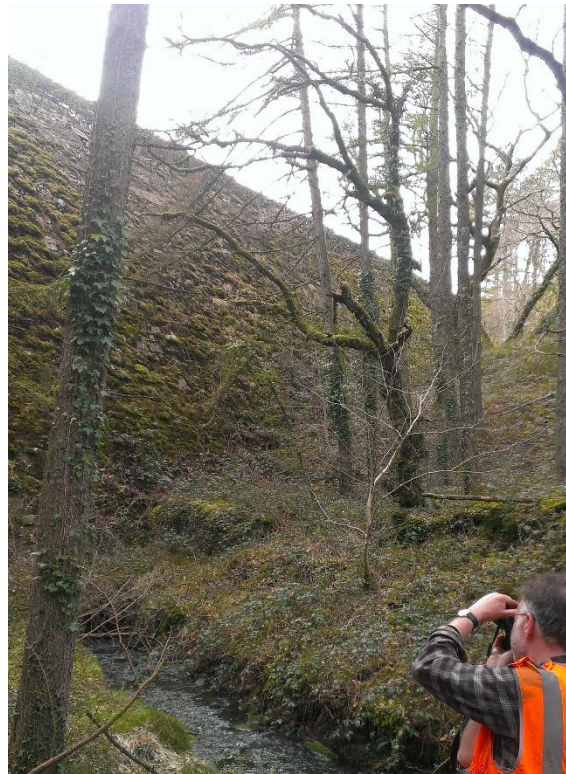
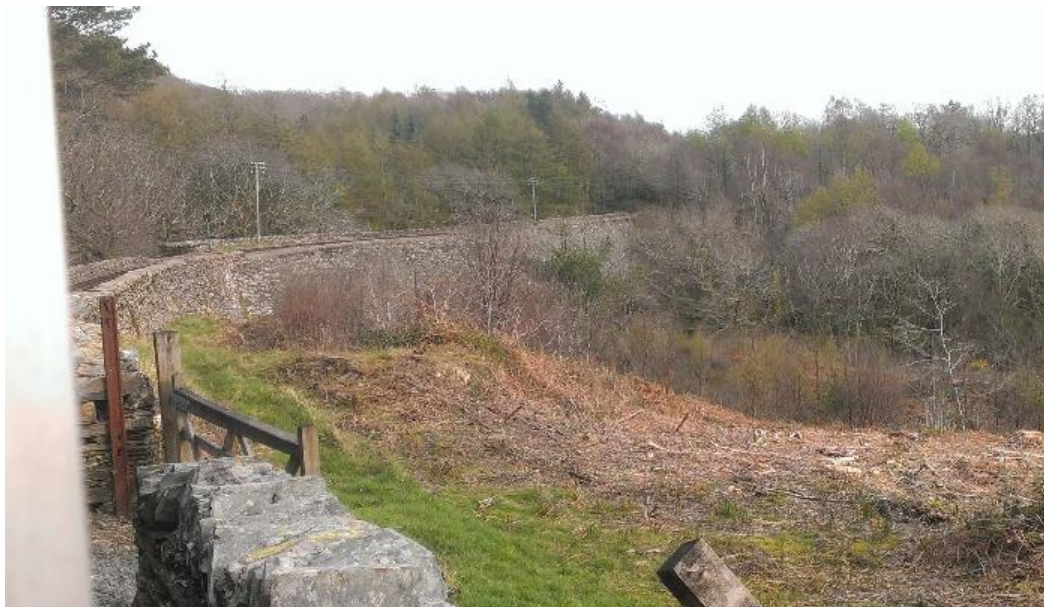
Figure 3.19: Cei Mawr, Ffestiniog Railway. Reputedly, the largest drystone embankment in Europe it stands approximately 19m high with a continuous curve. It is completely freestanding, with a stream running under it (as can be seen in image a) through a culvert in the base. It was buttressed to the North East and South East in the late 1800's

Cei Mawr (Figures 3.19) is reportedly the largest drystone embankment in Europe (Festrail, 2017). This embankment is entirely free standing and is constructed on a curve as can be seen in Figure 3.19b. From the face, it appears to be constructed as a large freestanding wall, and probably contains some of the largest stones on the railway by face size. There are culverts running under the embankment, as with many of the other embankments, to allow water to pass.

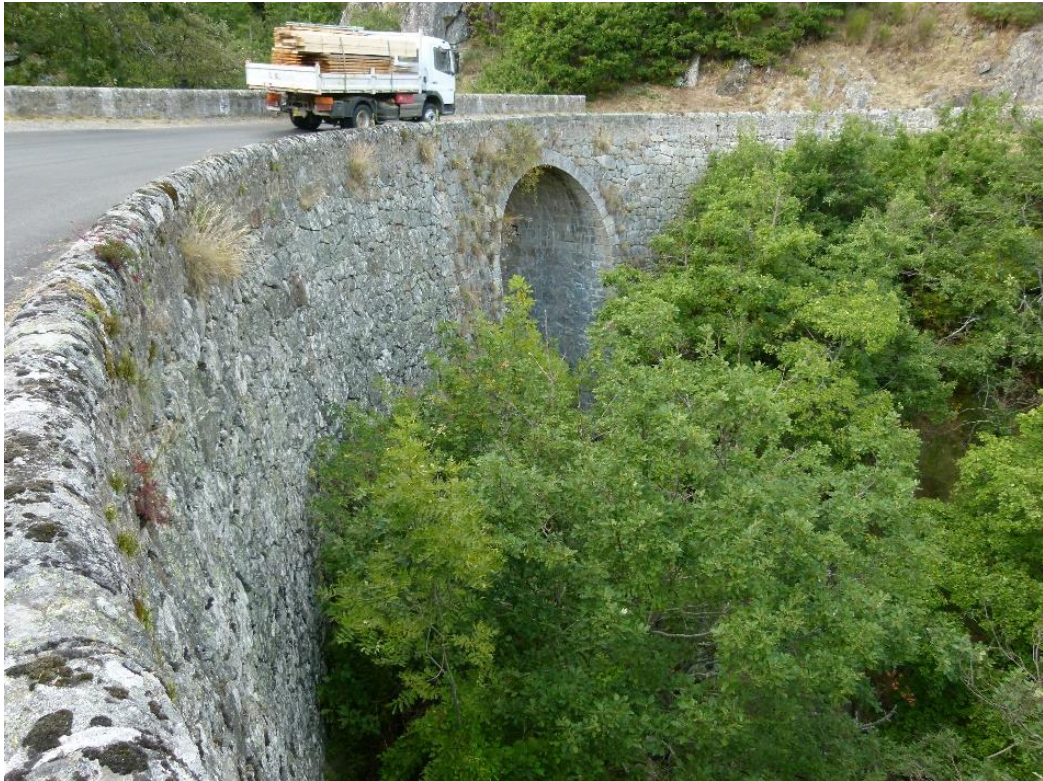
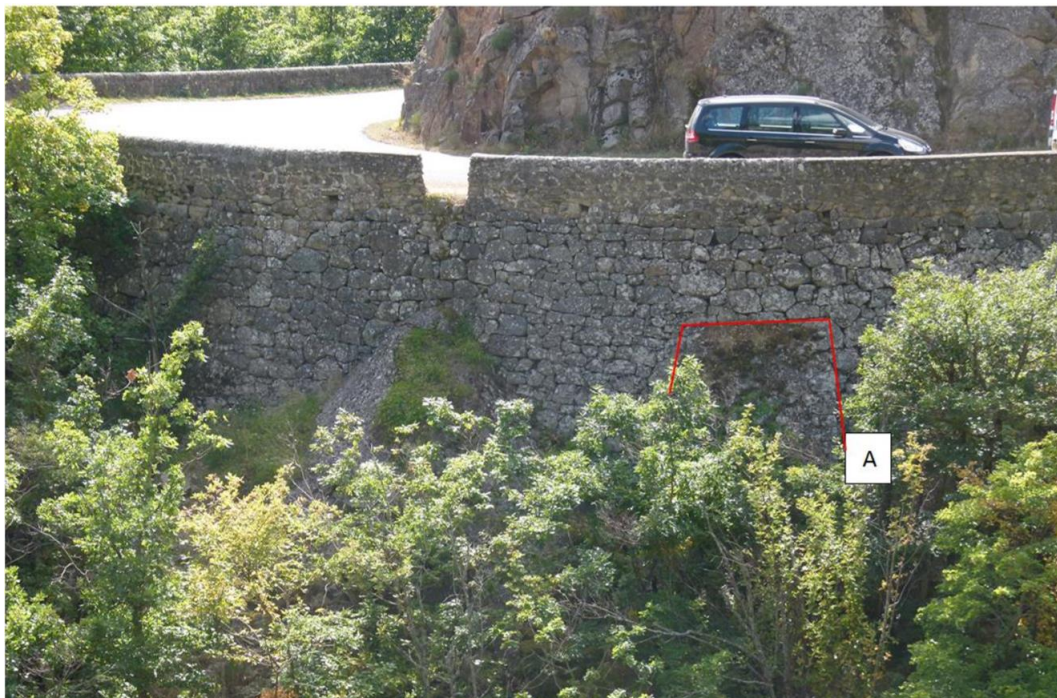
Figure 3.24 shows the oldest wall seen in France. This wall supports a sharp bend in the road and has become deformed over the years, causing it to be buttressed in places. The French wallers were keen to show us this wall due to its age, as well as to discuss the changes in building practice. In this area, historic walls were constructed with a flat back forming a wedge shape. Modern walls are constructed using a stepped back. This not only reduces the amount of material required but makes use of the earth pressures acting on the back of the wall to aid stability.

Figure 3.24: Historic wall supporting D998, France. This wall is constructed directly off the bedrock below to cross a river valley around the mountain. The forces this wall are subjected to are unusual due to the tight curves both of the wall and a tight opposite hand bend, prior to the wall to the west, and the subsequent forces induced by vehicles. The wall is buttressed to the west (A) to help resist these forces.

Image showing the tight bend prior to the historic wall shown in figure 3.24 hence inducing forces not typically seen on drystone construction.

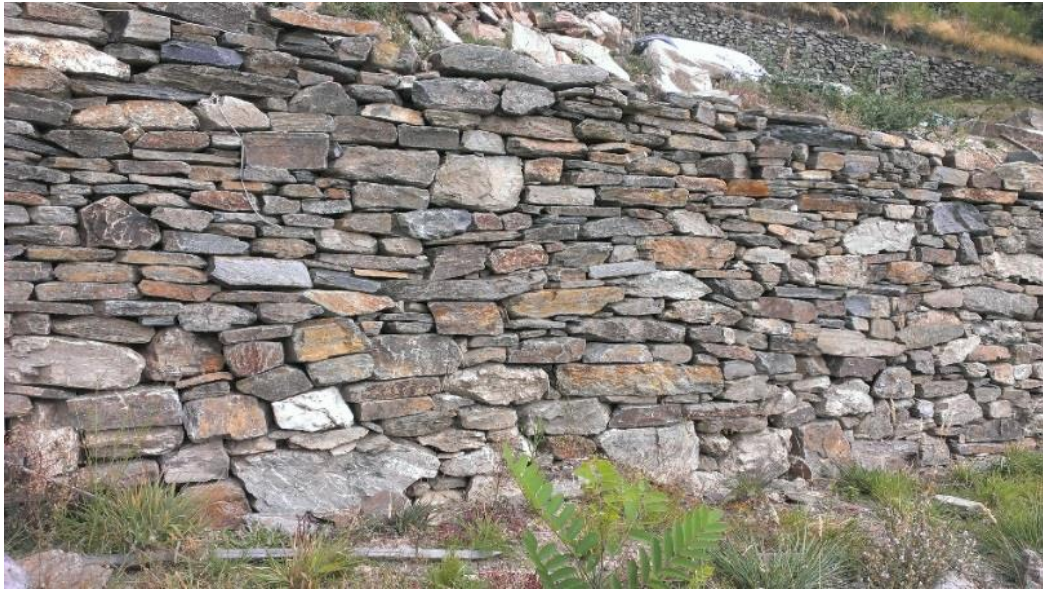
Figure 3.25: Training wall, walling School, France. Amateurs constructed this wall as part of a course. While not as neat or as visually pleasing as the professional wallers would like, it is perfectly adequate structurally and still follows the main construction principles.

The wallers in France have also set up a walling school where novices and professionals alike have the opportunity to learn new skills and learn from each other. The wall in Figure 3.25 is such a wall built as part of the walling school. This wall is not as visually pleasing as many of the walls seen in France, which may be taken as a sign of lesser quality and hence stability; however the wallers although not satisfied with how it appears visually, concede that structurally it is still sound and more than adequate for its job.

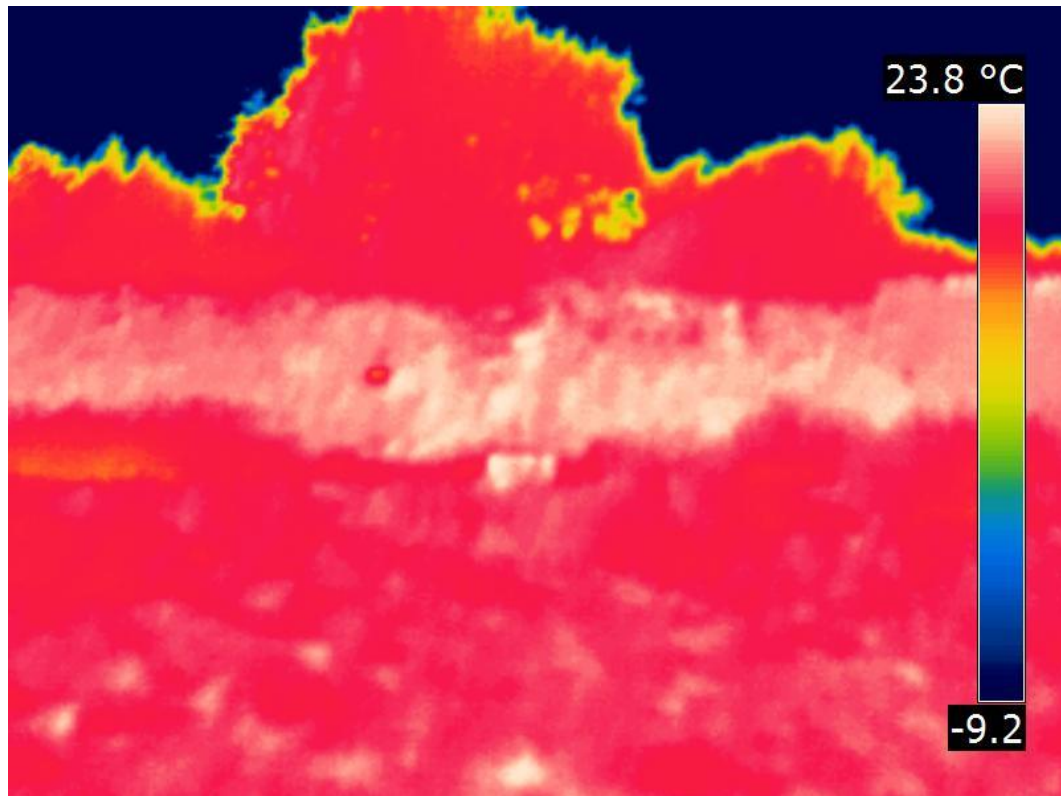
Image taken 15:00 06/06/13; wall face shows relatively uniform temperature. Significantly cooler areas correspond to small alcove and vegetation at wall face. Small variations in temperature across face likely due to the uneven surface due to weathering.

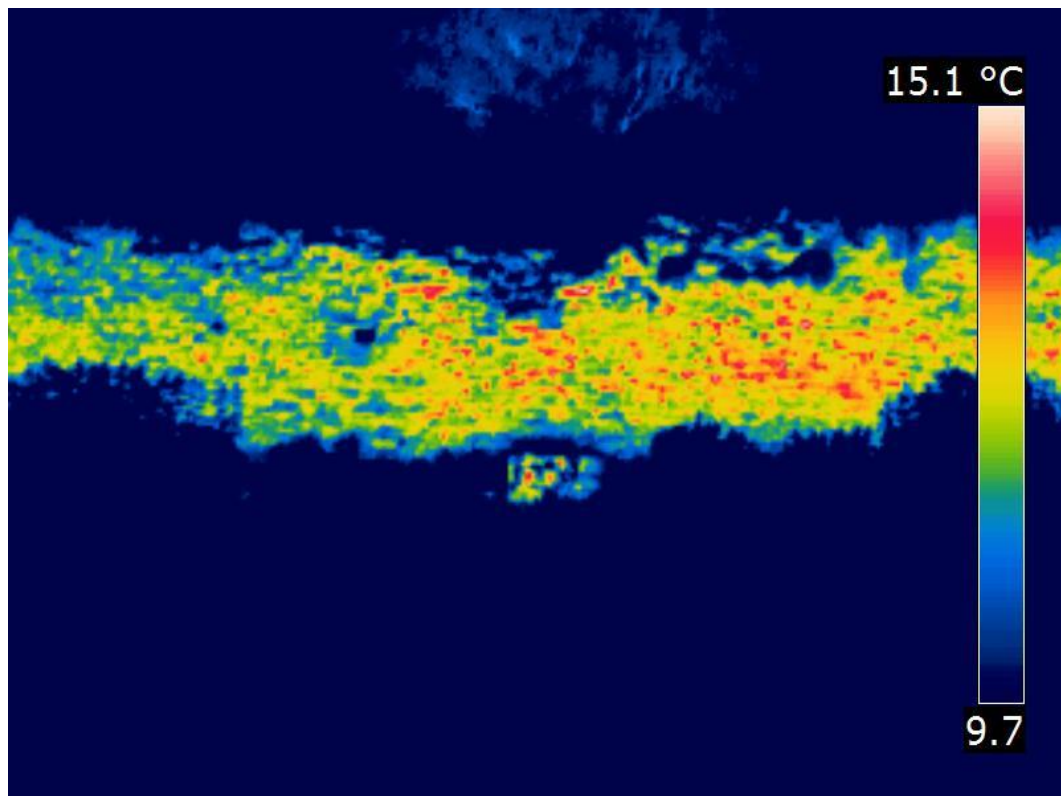
Image taken 20:00 06/06/13; where vegetation is present at the top of the wall it can be seen to be significantly cooler. Along 1&2 changes in temperature can be seen where construction changes.

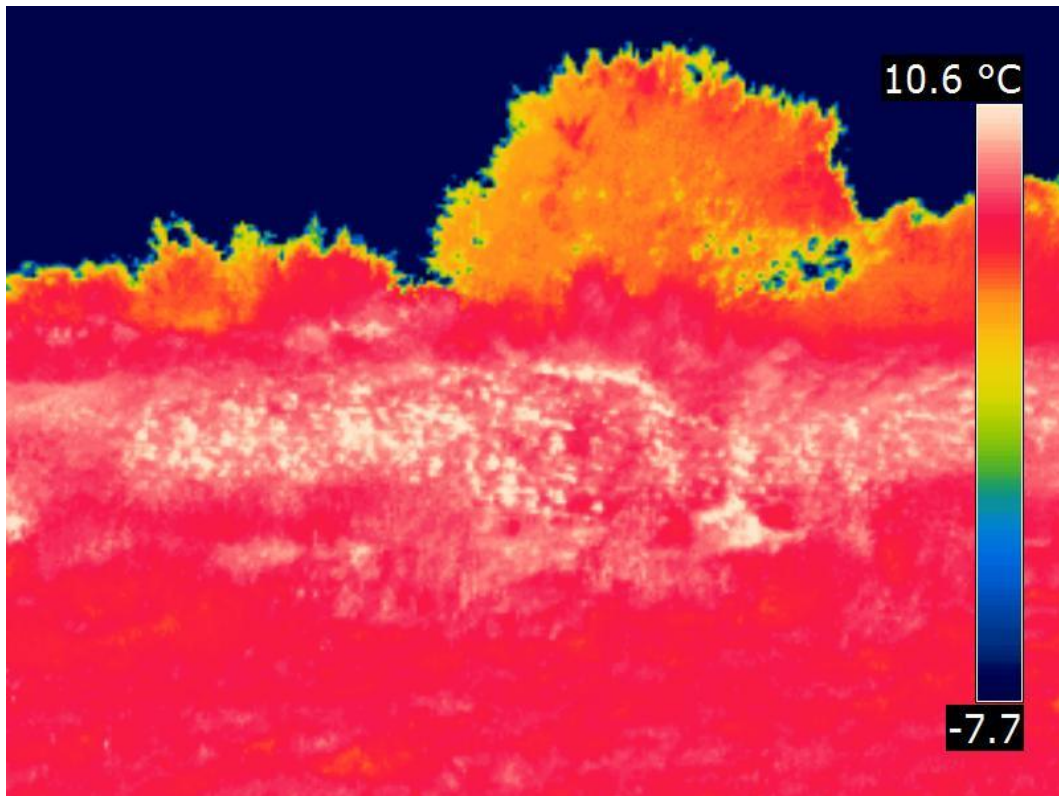
Image taken 05:00 07/07/13; individual stones across the wall face can be identified, possibly do to the wider joints in this area compared to other wall sections.

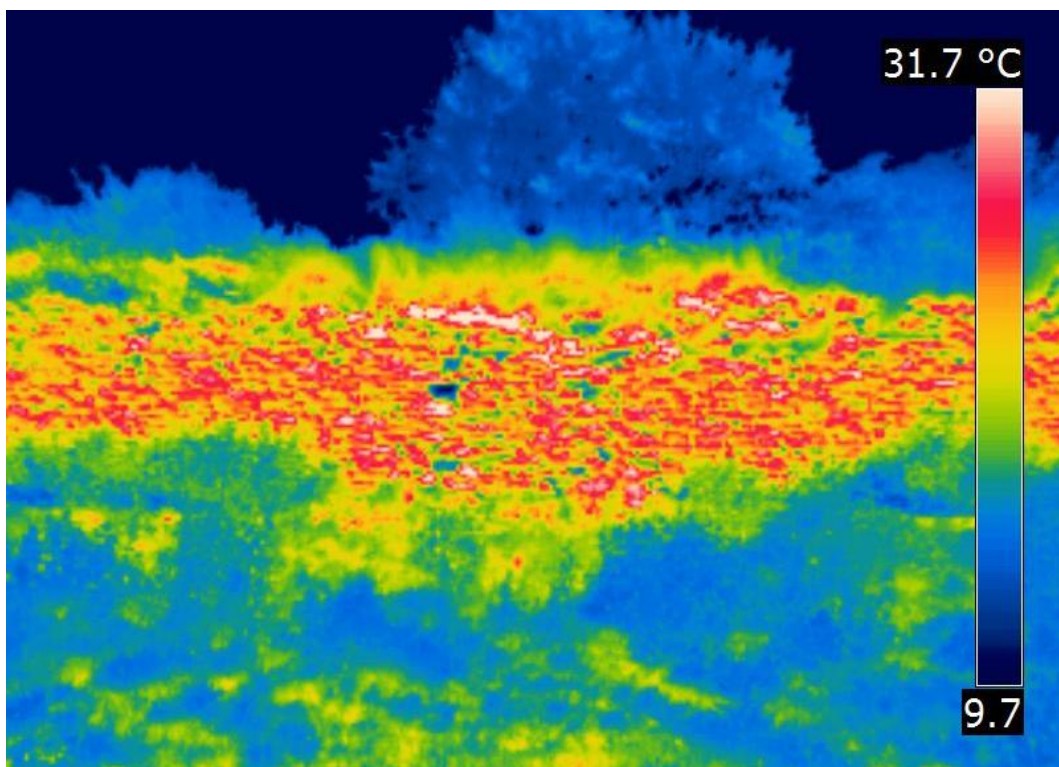
Image taken 08:00 07/07/16; as at 05:30 the individual stones within the wall can be identified in the thermal image

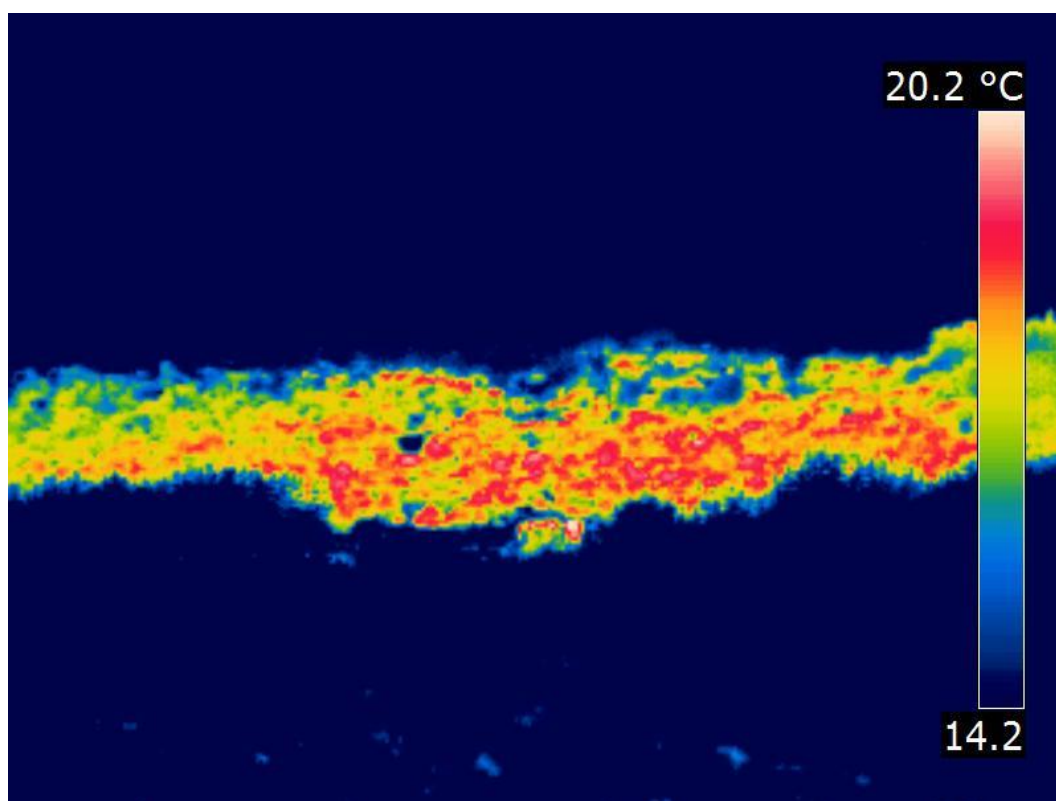
Image taken: 10:30 07/06/13; cooler areas of stone can be seen, these appear to correspond to areas of more severe weathering where the stone faces are set back from those around them.

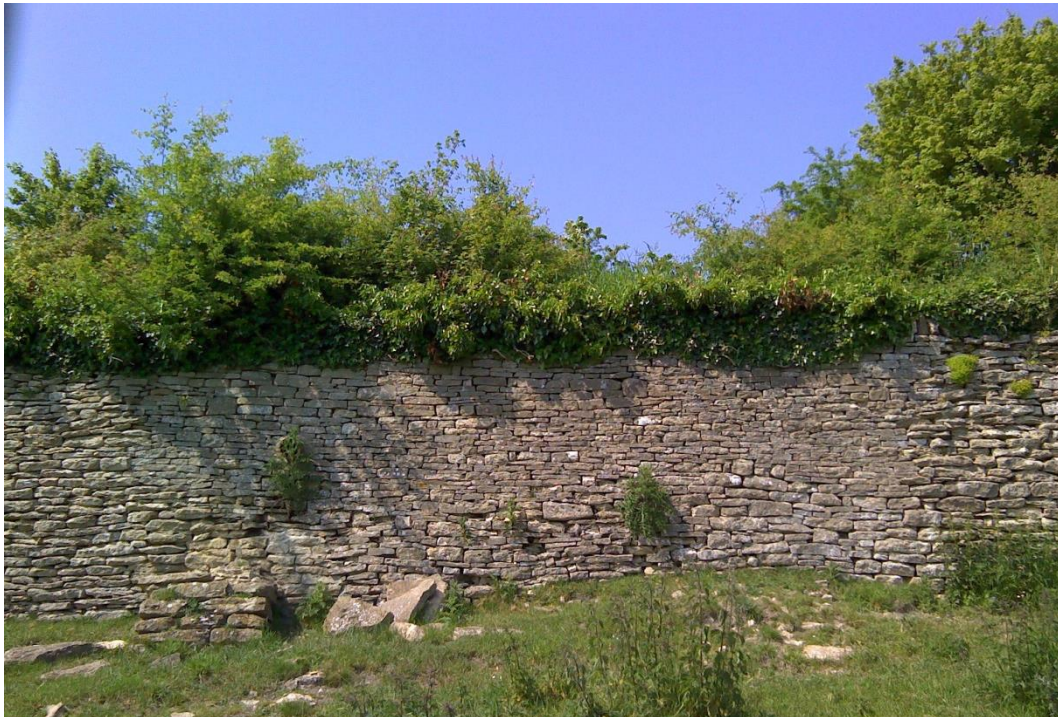
Visual image: 2 distinct areas of vegetation can be seen along with a buttress type feature to left of the section.

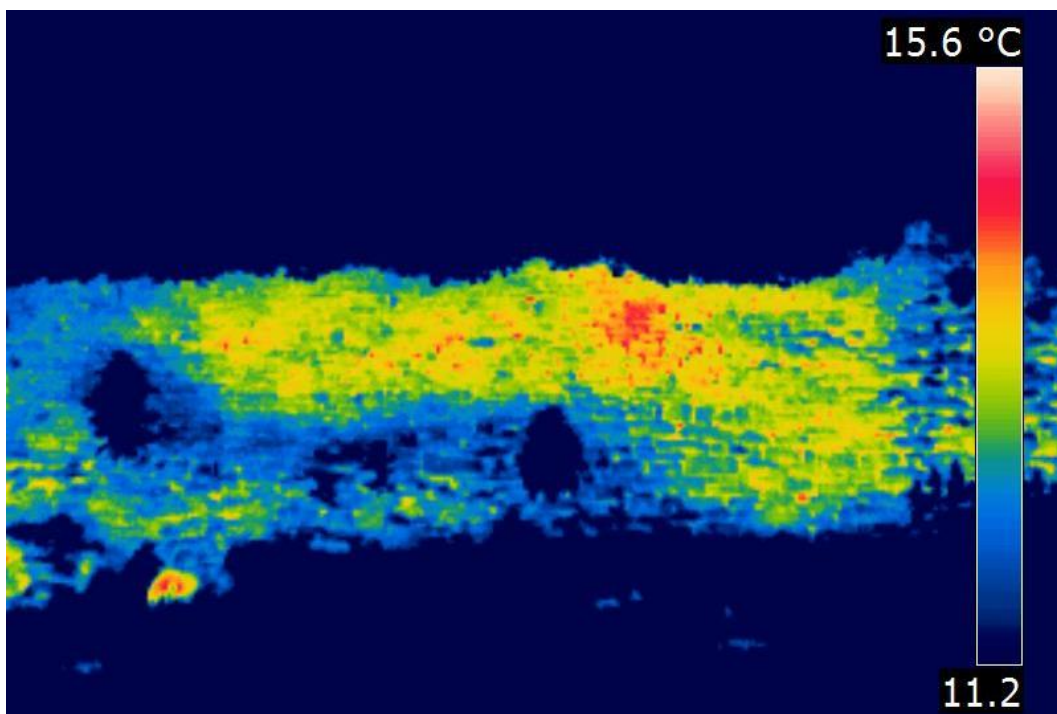
Image taken: 22:00 06/06/13; distinct cooler band between vegetation can be seen along with distinct temperature difference to construction style to the section to right of section 3.

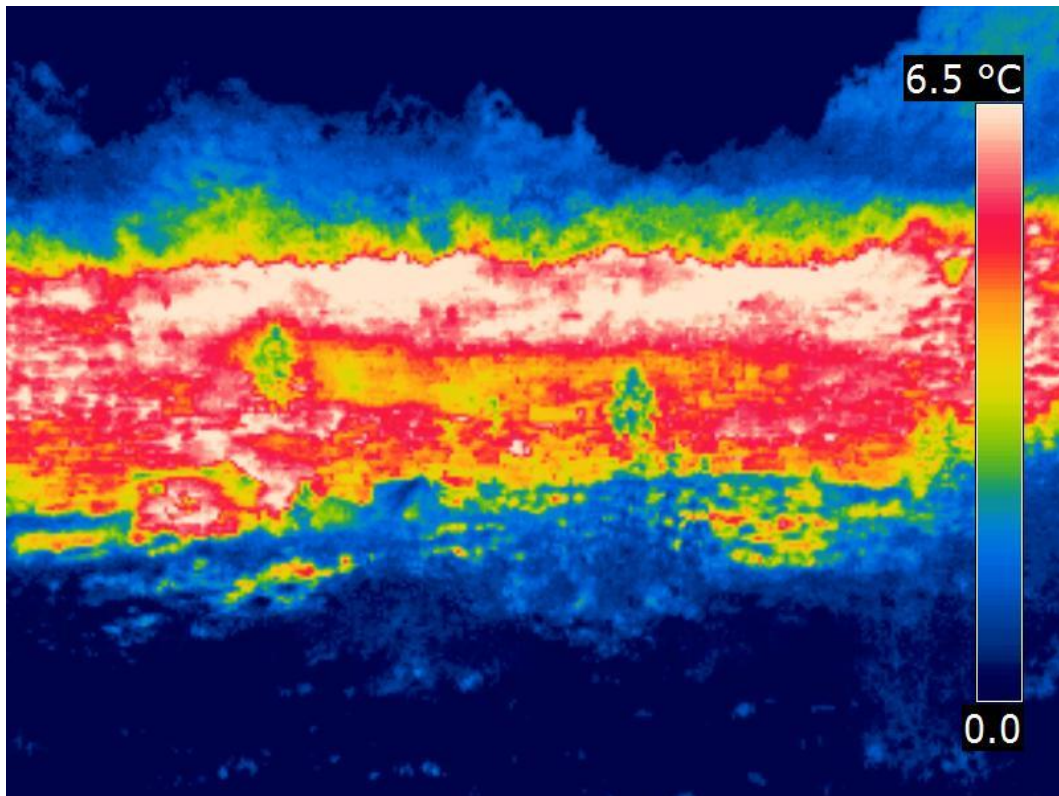
Image taken 05:30 07/07/13; Cooler band between two area of vegetation visible

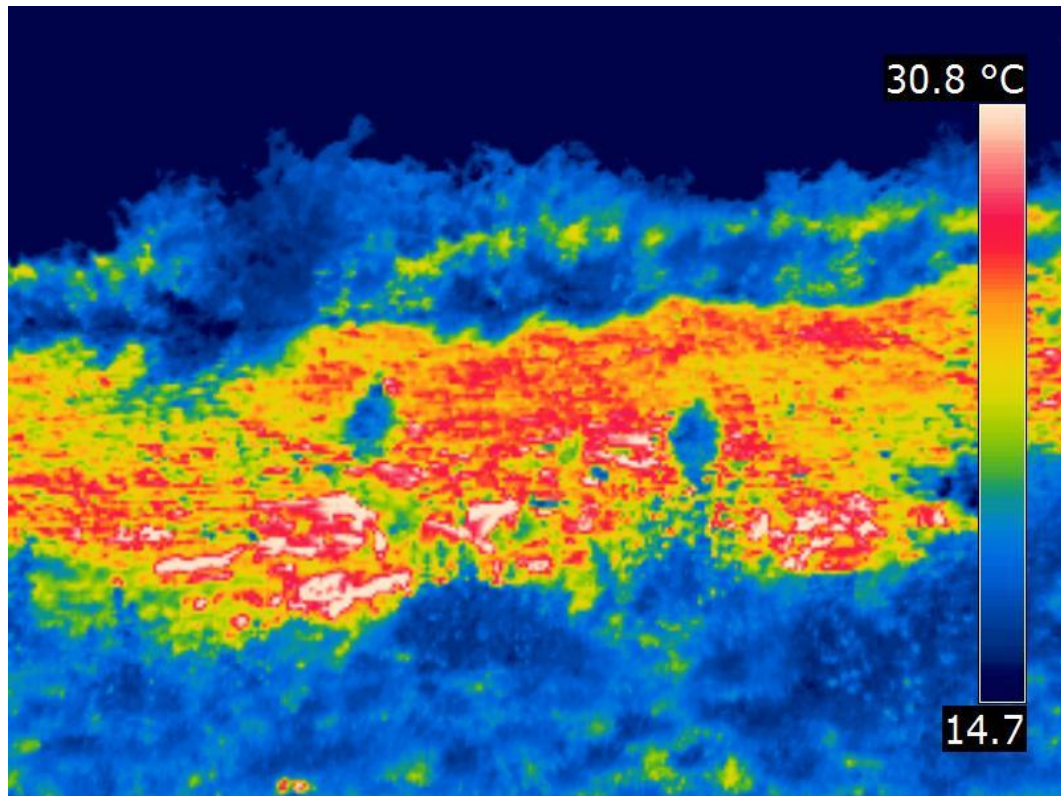
Image taken 10:30 07/06/13; cooler area between vegetation no longer visible. Some surface temperature variation seen, corresponding to variation in face construction and weathering of areas of stone.

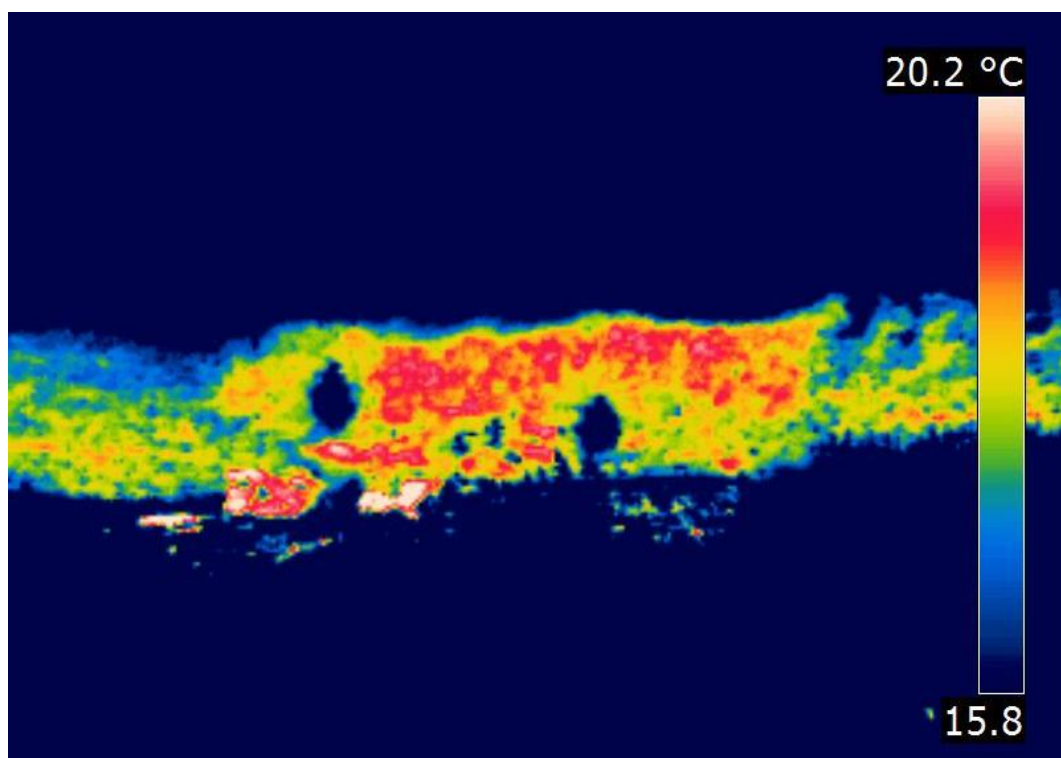
Image taken 13:00 07/06/13; Cooler area between vegetation becoming visible. Temperature differences between wall sections/constructions either side also visible.

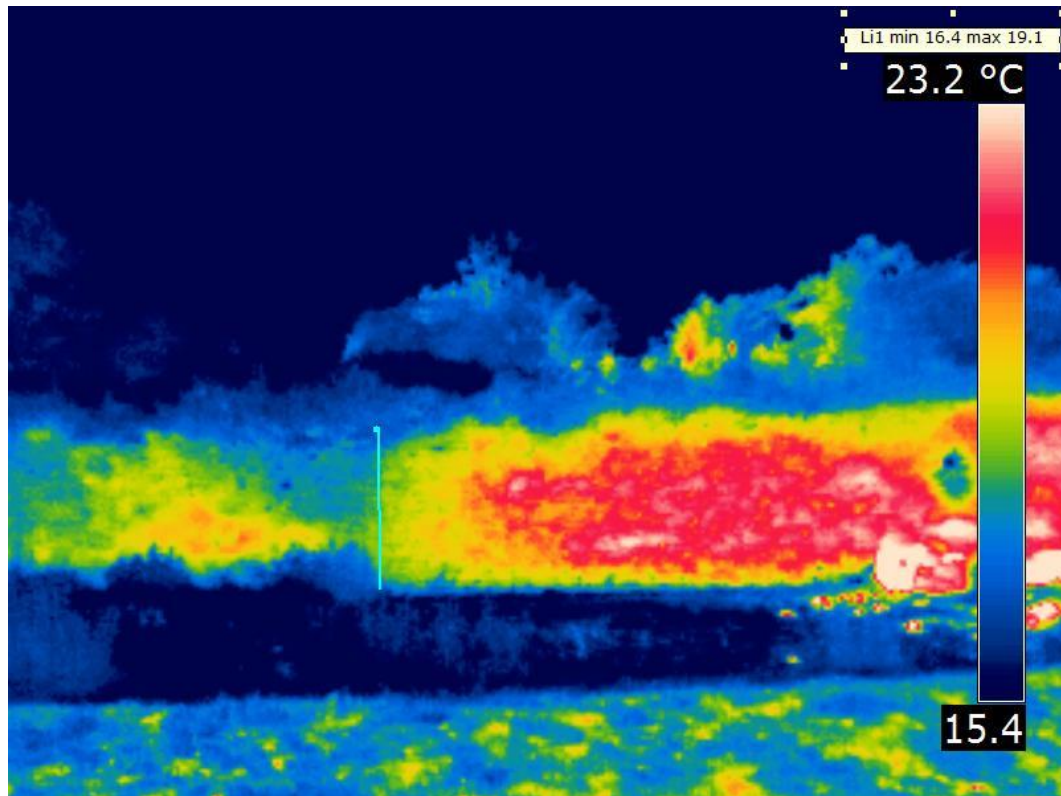
Image taken 17:30 06/06/13; uniform temperature across section. Distinct temperature difference between section 4 and section 5 can be seen (marked)

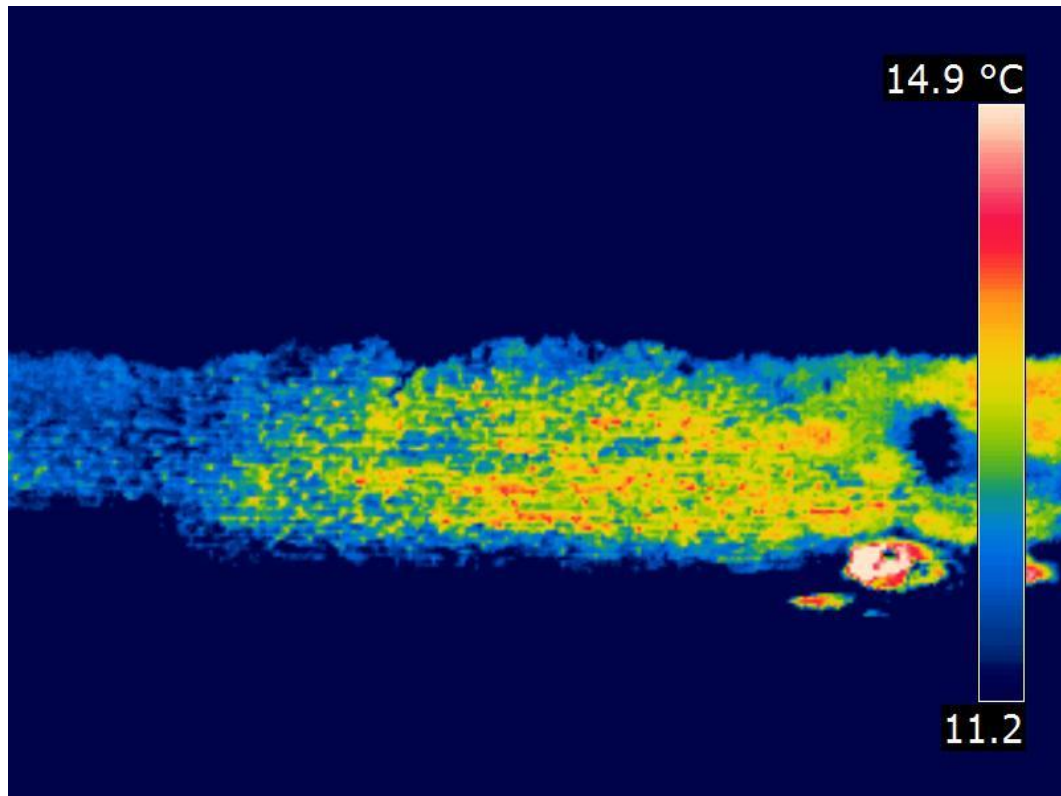
Image taken 22:00 06/06/13; temperature patterns as before. Two cooler areas in centre of wall can be seen, suggesting they may be in better contact with backfill than that around it.
